Figure 16 - Proposed Soil Excavation (0-2 Feet)

Former Ungemach Pottery - 26 Potters Lane/
 16 Main Street, Roseville, Muskingum County, Ohio

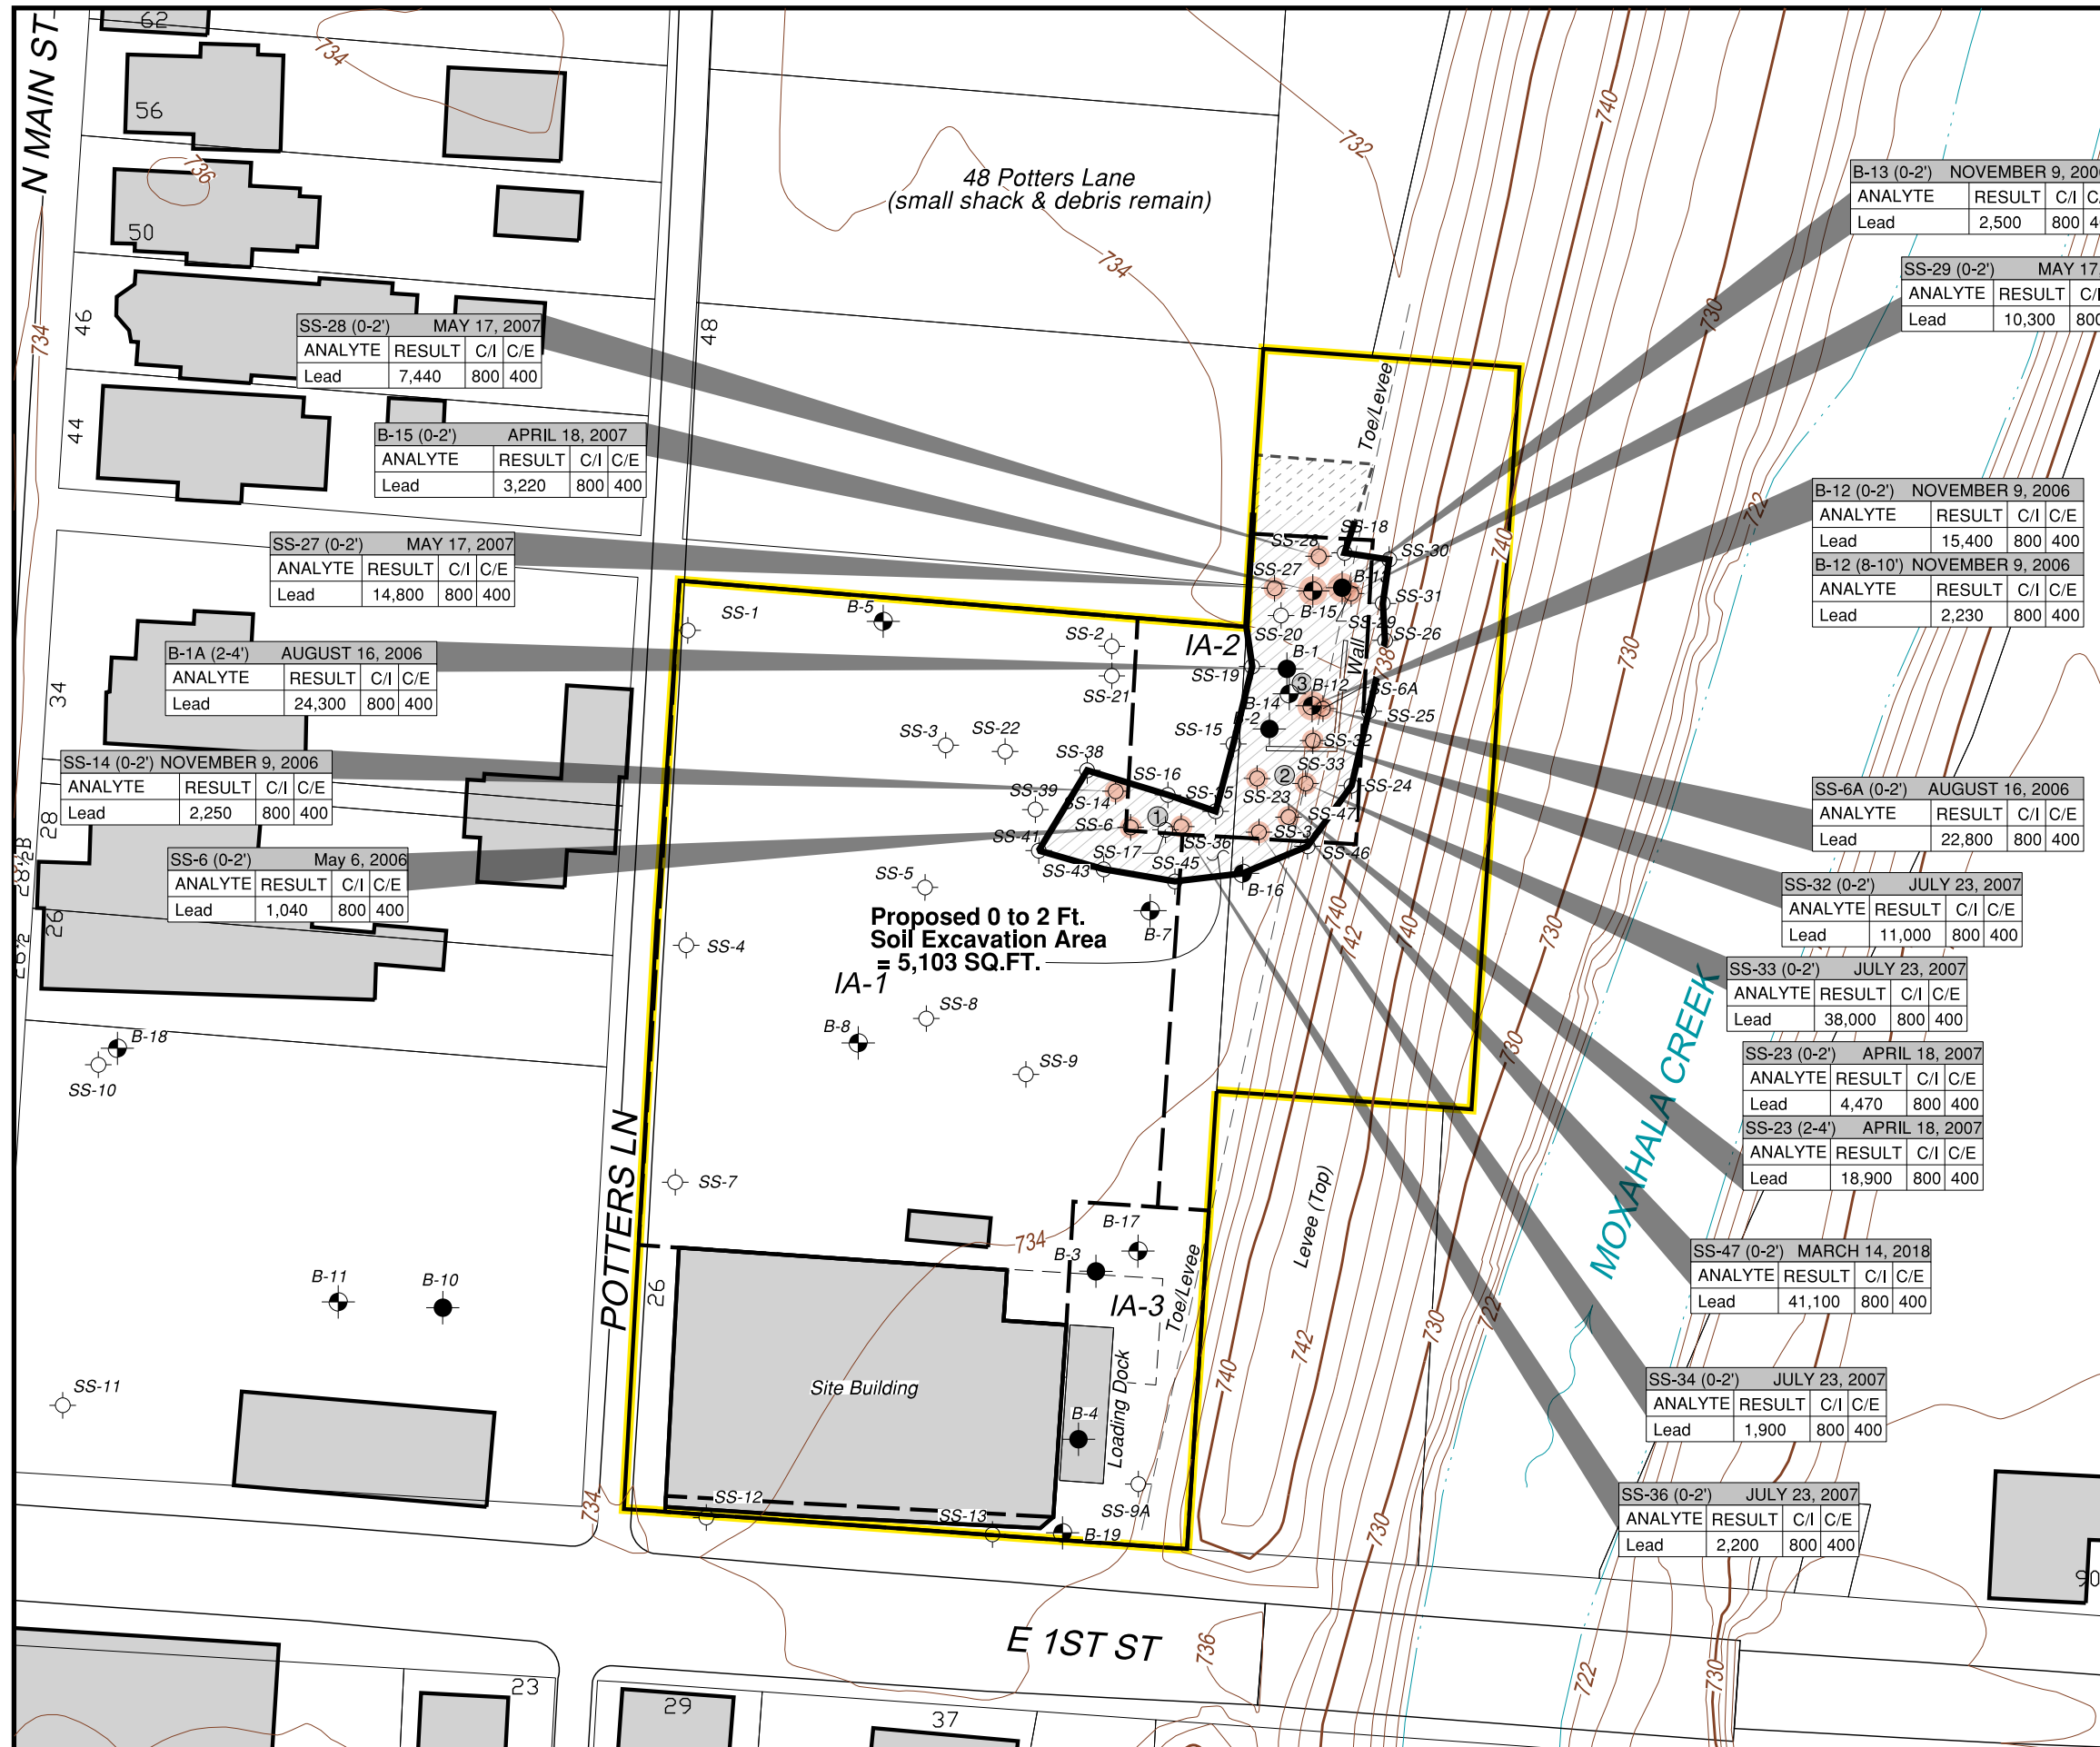
- IA-1 Footprint of the former pottery facility.
- IA-2 Waste accumulation/storage area.
- IA-3 Loading dock.

B-13 (0-2') NOVEMBER 9, 2006			
ANALYTE	RESULT	C/I	C/E
Lead	2,500	800	400

SS-29 (0-2') MAY 17, 2007			
ANALYTE	RESULT	C/I	C/E
Lead	10,300	800	400

B-12 (0-2') NOVEMBER 9, 2006			
ANALYTE	RESULT	C/I	C/E
Lead	15,400	800	400

B-12 (8-10') NOVEMBER 9, 2006			
ANALYTE	RESULT	C/I	C/E
Lead	2,230	800	400

SS-6A (0-2') AUGUST 16, 2006			
ANALYTE	RESULT	C/I	C/E
Lead	22,800	800	400

SS-32 (0-2') JULY 23, 2007			
ANALYTE	RESULT	C/I	C/E
Lead	11,000	800	400

SS-33 (0-2') JULY 23, 2007			
ANALYTE	RESULT	C/I	C/E
Lead	38,000	800	400

SS-23 (0-2') APRIL 18, 2007			
ANALYTE	RESULT	C/I	C/E
Lead	4,470	800	400

SS-23 (2-4') APRIL 18, 2007			
ANALYTE	RESULT	C/I	C/E
Lead	18,900	800	400

SS-47 (0-2') MARCH 14, 2018			
ANALYTE	RESULT	C/I	C/E
Lead	41,100	800	400

SS-34 (0-2') JULY 23, 2007			
ANALYTE	RESULT	C/I	C/E
Lead	1,900	800	400

SS-36 (0-2') JULY 23, 2007			
ANALYTE	RESULT	C/I	C/E
Lead	2,200	800	400
